REPORT OF MARINE SURVEY

**Valuation appraisal inspection
of the vessel**

**" MAI SUE II"
1981 Uniflite 41' Yacht Fisherman**

May 19, 2010

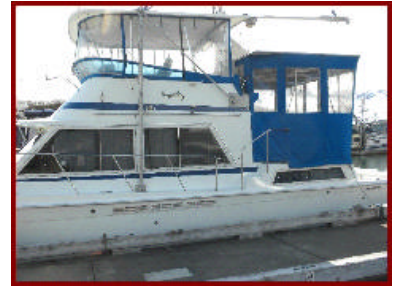
<i>Construction material:</i>	Fiberglass, with white gel coat surface.
<i>Stem:</i>	Solid, no cracks on external inspection. Moisture readings relatively Dry.
<i>Stem thru hull fittings:</i>	Chain locker drains thru stem. Currently unused as vessel now has a drum style anchor winch on deck.
<i>Side thru hull fittings:</i>	Plastic mushroom head fittings: Bronze mushroom head fittings: used for Bilge/Sump drains, Sink drains,
<i>Rub rail:</i>	Rub rail is stainless steel on Well secured in good condition with only minor scrapes. backing.
<i>Port Lights:</i>	Port and starboard sides.
<i>Engine vents:</i>	Vents are attached and in good condition- no cracks sighted.

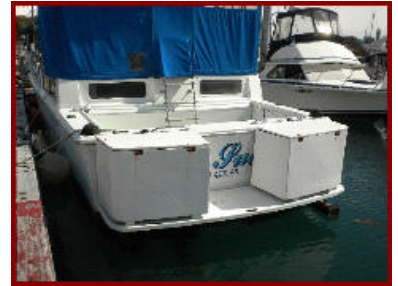
<i>Transom:</i>	Conventional transom with door, Swim grid w/ custom fish boxes with drains.
-----------------	---

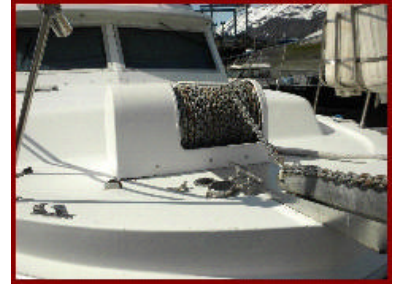
<i>Deck Surface:</i>	Molded, cored fiberglass deck construction (core not sampled). White gel coat with molded in non skid fiberglass surface. Good condition. Deck is solid under foot, no soft spots discovered.
<i>Moisture/Delamination:</i>	Moisture meter readings were all relatively Dry. No delamination or soft spots discovered.
<i>Toe rail(s):</i>	Molded in, no cracks or separation sighted.
<i>Anchor platform:</i>	Stainless steel with anchor roller. Well secured.
<i>Windlass:</i>	EZ Anchor drum type.

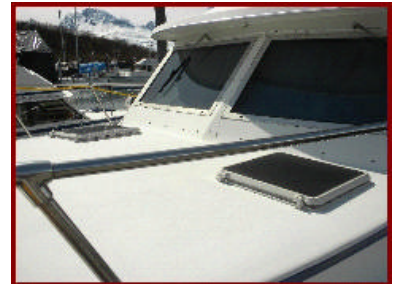
<i>Stanchions/side rail(s):</i>	Stainless steel, well secured.
<i>Cleats & fairleads:</i>	Horn cleats are all well secured to deck and functional.
<i>Cabin (house) to deck joint:</i>	Molded in -- some minor stress cracks.
<i>Deck hatches:</i>	Yes, well secured, seals in good condition, support arm(s) in place.
<i>Escape hatch(es):</i>	Forward cabin top.
<i>Cabin house window(s):</i>	Fixed, Sliding side windows.
<i>Port(s)/port light(s):</i>	Opening, all well secured and sealed to cabin top.

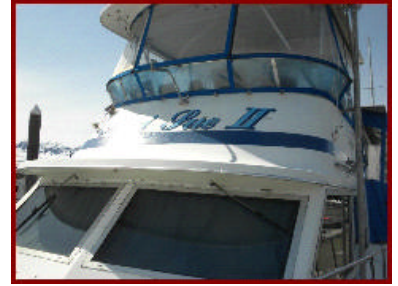
Construction material: Fiberglass. With Lexan windshields.

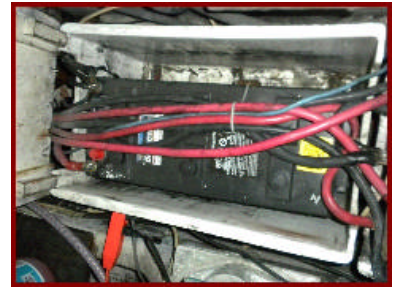
There are three batteries located in the engine compartment that are 4D Lead acid batteries which provide service to the main engine(s) plus house electrical and are wired in parallel producing 12 volts.

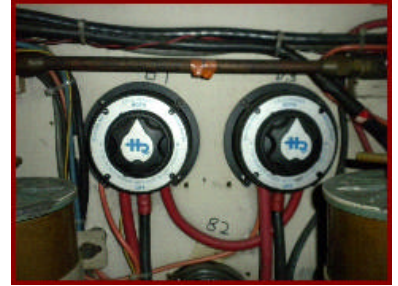
Yes Rotary switch is functional. NOTE: Recommend alternating use of battery one and two when using vessel. Only use the battery switch All position if both batteries are low or when charging with battery charger/alternator.

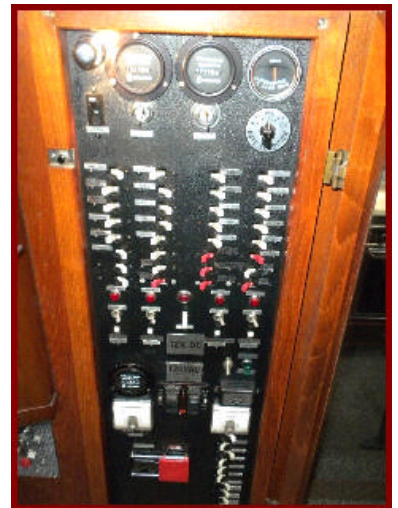
Yes located in main salon.

Wire nuts were sighted for some DC connections. RECOMMENDATION: ABYC E-11 recommends that wire nuts not be used for any electrical wire connections. Replace with crimp on butt connectors or use of terminal strips.

Not all well secured. Some loose wiring runs sighted. RECOMMENDATION: ABYC E-11 currently recommends that all electrical wiring runs be secured no further apart than every 18 inches. Recommend compliance.

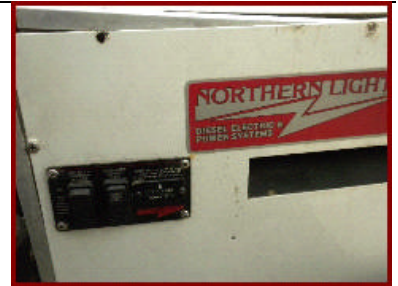
Location/Manufacturer: Steering compartment lazarette. Northern Lights. Diesel, 3 cylinder.

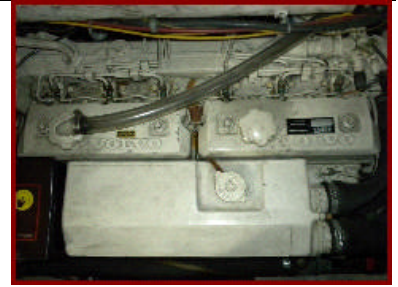
Two, Volvo Penta, TMAD 73P Inboard Shaft driven, Diesel, In Line 6 cylinder, Turbo After cooled, 375 HP.

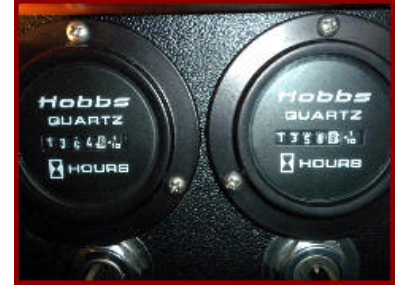
hrs on meter. 1364 Port and 1358 Starboard.
