REPORT OF MARINE SURVEY

**Valuation appraisal inspection
of the vessel**

**" MAI SUE II"
1981 Uniflite 41' Yacht Fisherman**

May 19, 2010

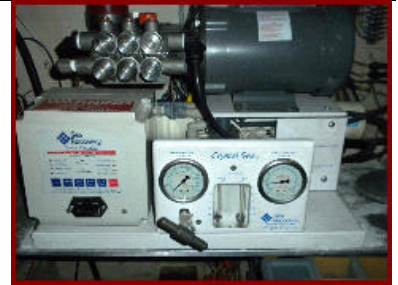
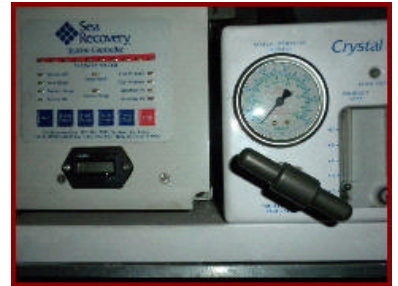
Manufacturer: Sea Recovery.
Rating and capacity: These are typically very sensitive units. Owners manual must be read and fully understood before testing/using the unit.

Secured: Yes.
Location: Under cabin sole via galley.
Inspection/cleaning access: Good.

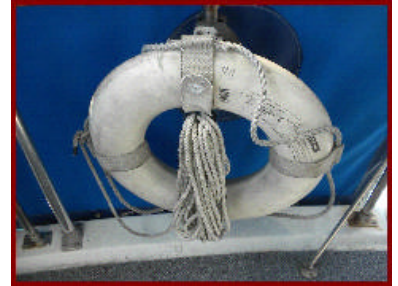
Throwable type PFD's:

The type of USCG approved throwable PFD devices sighted were: USCG approved Ring buoy(s), All appear to be in good condition.

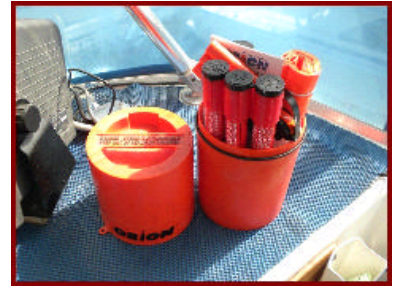
Visual Distress Signals:

12 Ga Aerial, Red hand held, Hand held smoke signals, **NOTE: All visual distress signals have a printed expiration date- 3 years from date of manufacture. It is recommended that expired signals be retained for backup. You must have at least three aerial or three red hand held signals that are current.**

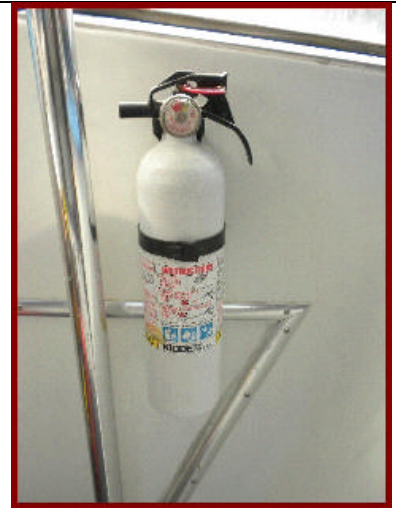
Dry Chemical Size I:

Three USCG approved USCG approved extinguisher(s) sighted at the following locations: Aft cabin Engine space Main salon V-berth.

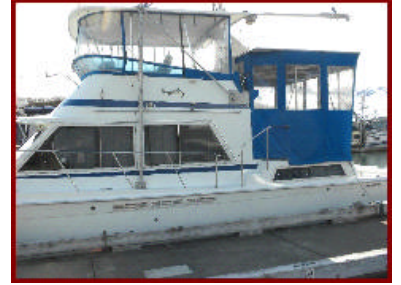
Dinghy Davits:

Vessel has Hydraulic crane mounted on F/B Hardtop.
